Replacing a failing tooth with an implant-supported crown – strategies for ensuring an esthetic treatment result

The restorative team will often be exposed to significant challenges in trying to replace a failing tooth in the esthetic zone. Different treatment alternatives exist but the least invasive method in regard to neighboring teeth would most certainly consist of the utilization of implant-supported prosthodontics. Implant site development, surgical approach, prosthodontic handling with utilization of appropriate components and materials are vital issues to consider in the therapy.

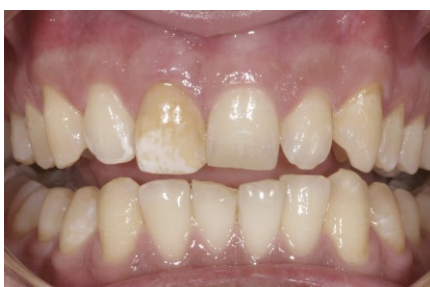
1. View from initial consultation. The tooth 11 is mobile with a deep gingival pocket and exhibits a soft tissue swelling marginally.

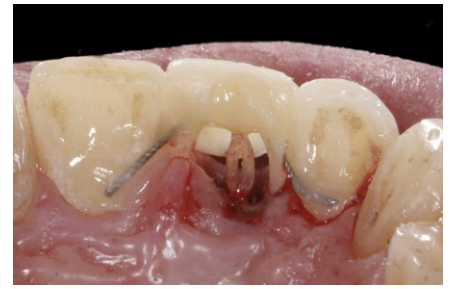
6. A provisional tooth which has been bonded to neighboring teeth is hollowed out and stretched in order to force the remaining root to erupt.

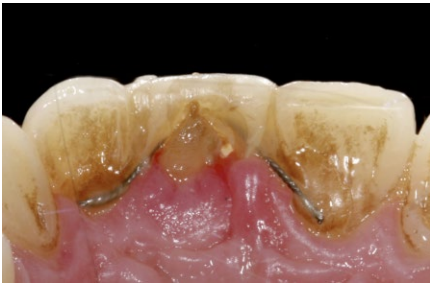
7. Four months later the root has erupted significantly and the supporting tissues have followed, resulting in a vertical augmentation of both soft and hard tissues.

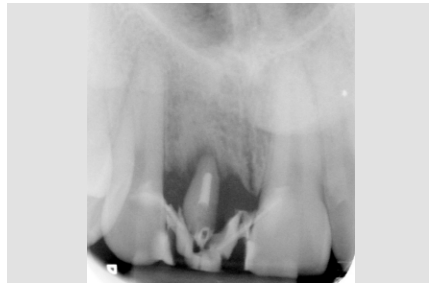
8. X-ray indicates bone apposition even superior of the marginal ridge.

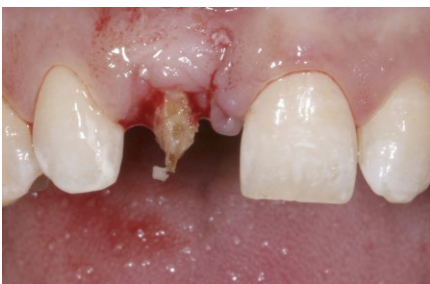
10. The remaining root tip is carefully extracted without lacerating the soft tissues using a periosteal elevator and appropriate forceps.

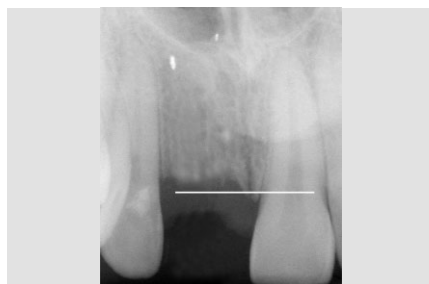
11. The cervical contour of tooth 21 is delineated on the X-ray.

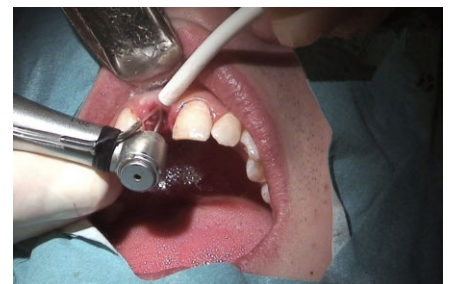
12. The orthodontic extraction has resulted in a dense bone quality, a frequent finding. This will allow for an immediate flapless implant installation followed by immediate temporization aiming for maximum "pink" esthetics.

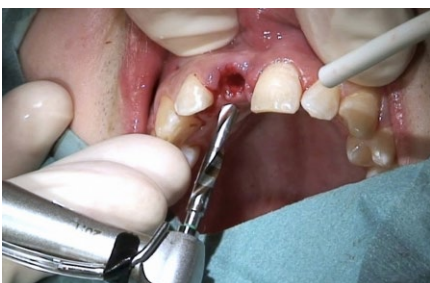
13. The preparation for the implant will have to be considered thoroughly since this is performed according to a "flapless" protocol.

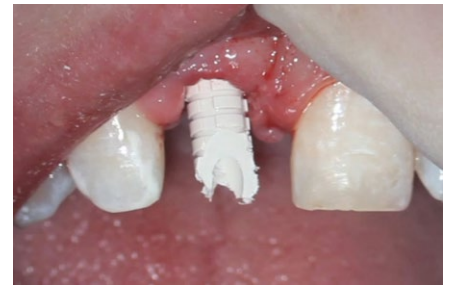
18. A TempDesign temporary abutment (ASTRA TECH Implant System) and a 3M ESPE Ion shell crown are used to fabricate an individually shaped temporary crown. The TempDesign component has to be cut for proper length.

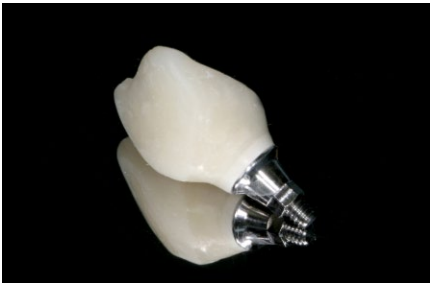
19. Temporary crown finished and ready for seating.

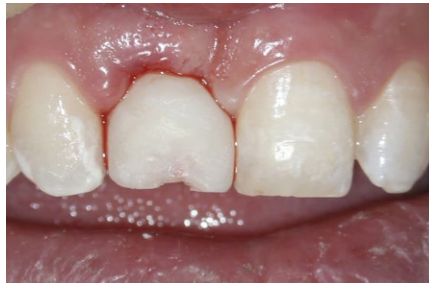
20. The situation clinically just after seating of the temporary crown. Mild, but not undue, ischemia can be noticed since it exerts some pressure towards the soft tissues. This is where the shaping of the "emergence profile" starts.

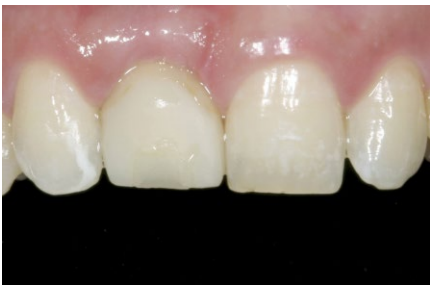
22. The temporary crown is trimmed a few months later to shape the soft tissues further and this is the situation after almost 6 months.

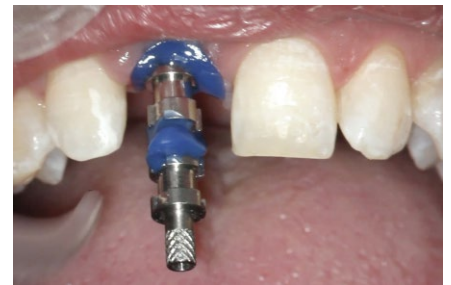
24. Impression coping on implant level is modified with a light cured acrylic (block-out resin e.g. Ultradent) to be able to replicate the soft tissue profile created.

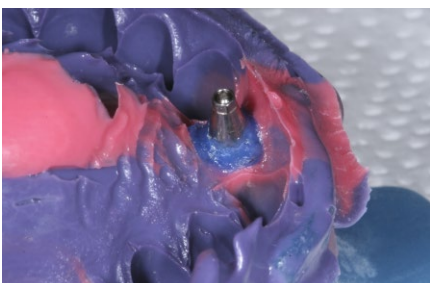
25. A customized impression tray is used for obtaining an impression together with Polyether material.

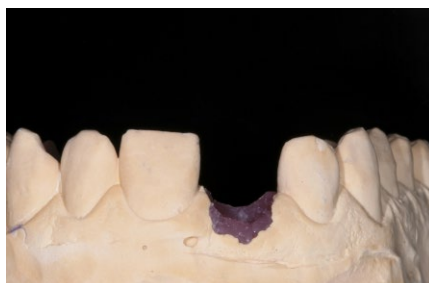
26. Working model with a detachable soft tissue mask and implant replica.

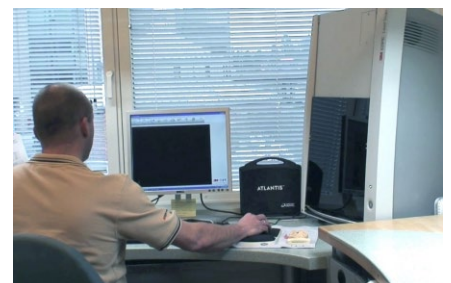
27. The model is scanned in the 3M ESPE Lava scanner and the files are sent to the DENTSPLY Implants ATLANTIS production unit where an individually designed abutment will be manufactured.

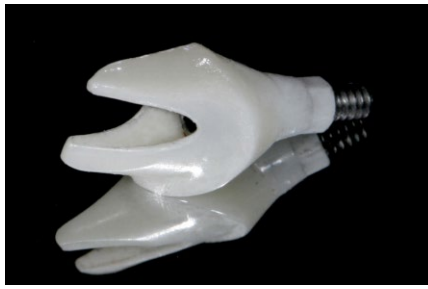
29. The finished ATLANTIS abutment, zirconia is delivered to the laboratory.

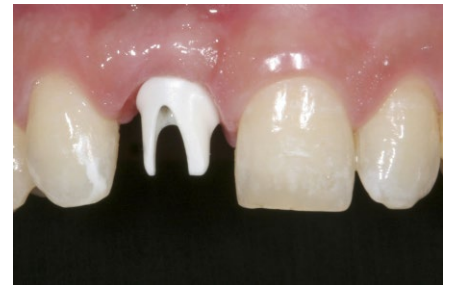
30. The abutment is tried in and checked clinically with light finger force of the abutment screw before proceeding with the construction of a crown restoration.

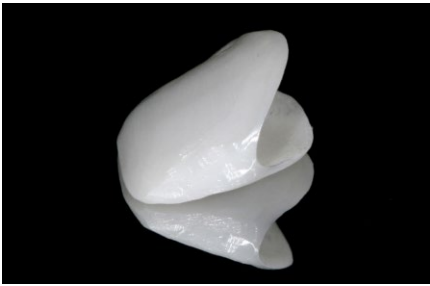
31. A 3M ESPE Lava zirconia coping is produced after scanning the ATLANTIS abutment.

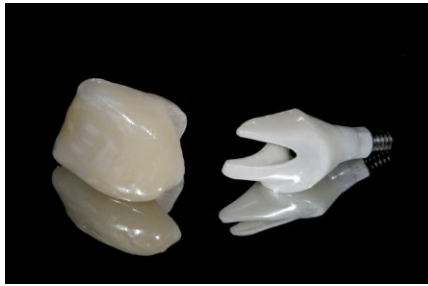
32. The finished ceramic crown and the abutment ready for delivery to the clinic.

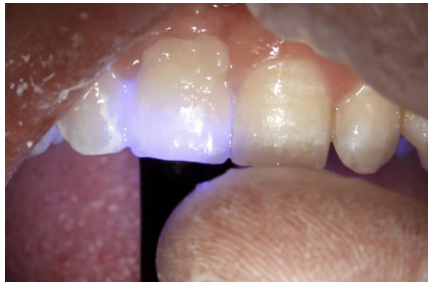
35. The crown is cemented with 3M ESPE Rely X "Unicem". The excess material is "frozen" by a short exposure with the curing unit and can then be removed before chemical setting starts. Notice the translucency.

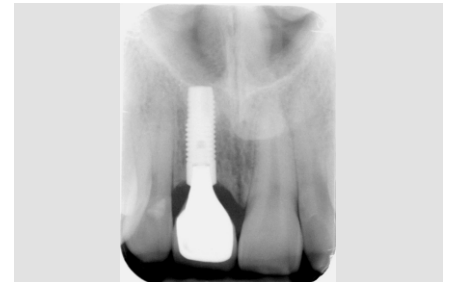
36. Seating and removal of excess cement is visualized in this X-ray at the 6 month recall.

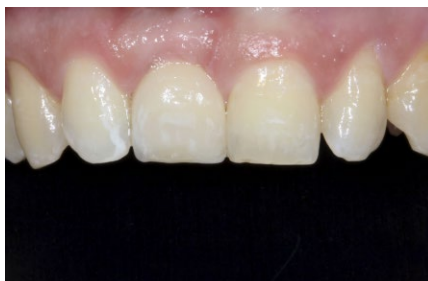
38. At the 6 months recall, the soft tissues have stabilized and the symmetry is even better. Note that a transition from smoking to snuff has resulted in gingival recessions on tooth 22 and 23.

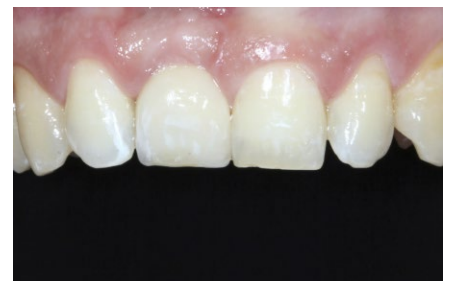
39. The one year recall shows excellent soft tissue stability around the restoration. The patient also stopped using snuff after firm counseling.
